20. ABSTRACT (Continue on reverse side if necessary and identify by block number) Cane Creek Watershed Dam No. 19 is a linear earthen structure 2 550 feet long and 20.9 feet high with a crest width of 13 feet. It has upstream and downstream slopes of 1V:2.6H and 1V:3.1H respectively. The lake has 2.194 acre-feet of available flood storage, but it normally remains empty nine months out of the year. The reservoir has a drainage area of 3 315 acres (5.18 mi 2). It is predominantly farm and pastureland with an average ground slope of approximately 4%. The dam has a relatively uniform cross-section along most of its length. The crest undergoes little change in elevation and has a fairly constant width.

PHASE I INSPECTION REPORT
NATIONAL DAM SAFETY PROGRAM
TENNESSEE

Name of Dam Cane Creek Watershed Dam No. 19
County Lauderdale
Stream Hyde Creek - Tributary of Cane Creek
Date of Inspection March 12, 1981

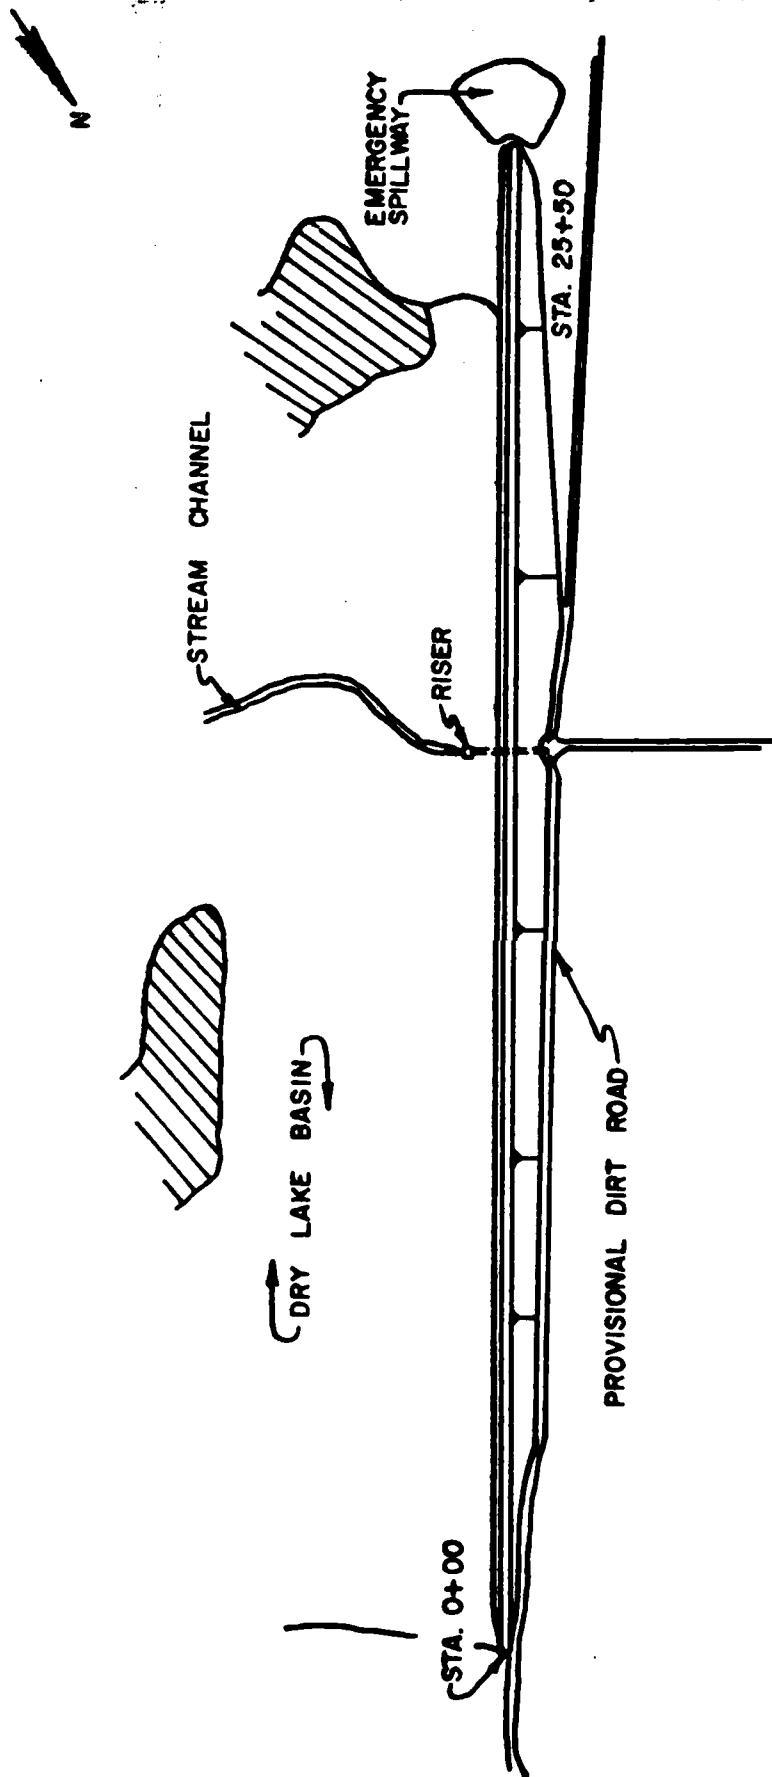
GENERAL PLAN
SCALE: 1" = 300'

No indications of seepage were observed on the embankment or in the area immediately downstream. A few wet areas do exist along the toe, however, their restriction to low lying areas indicates that they are probably due to pooled surface runoff (see photo no. 10). Impounding water at the sediment pool level for only a few months out of the year gives the embankment little opportunity to develop seepage problems.

//// - POOLED WATER

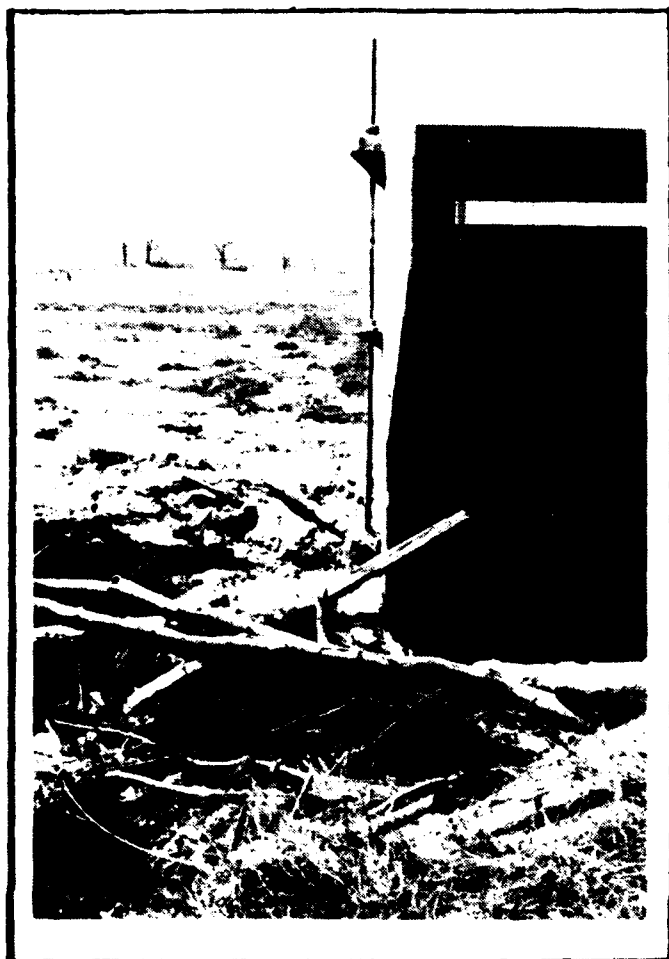
PHOTO NO. 5

- 3.1.2 Service Spillway - The service spillway appears to be in excellent condition. The riser shows no significant signs of spalling or other weathering. There is, however, considerable debris at the draw-down that could obstruct flow (see photo nos. 5 and 6).

2. Provide some type of slope stabilization or other protection for the upstream slope of the dam.
3. Clear the debris from the natural channel around the mouth of the drawdown.
4. Repair rutting and trail formation on the crest and downstream slope of the dam.
5. Keep cattle and unauthorized vehicles off of the embankment.
6. Have the dam reinspected when it is impounding water.
7. Continue a program of regular inspection and maintenance.
8. Develop an emergency action plan to warn downstream residents in the event a serious problem develops with the dam.

- 1) Repair benching and install appropriate wave protection on upstream slope prior to impounding water.
- 2) Remove debris accumulated around service spillway riser.
- 3) Repair erosion and rutting on crest and downstream slope.
- 4) Drain wet areas occurring along toe.

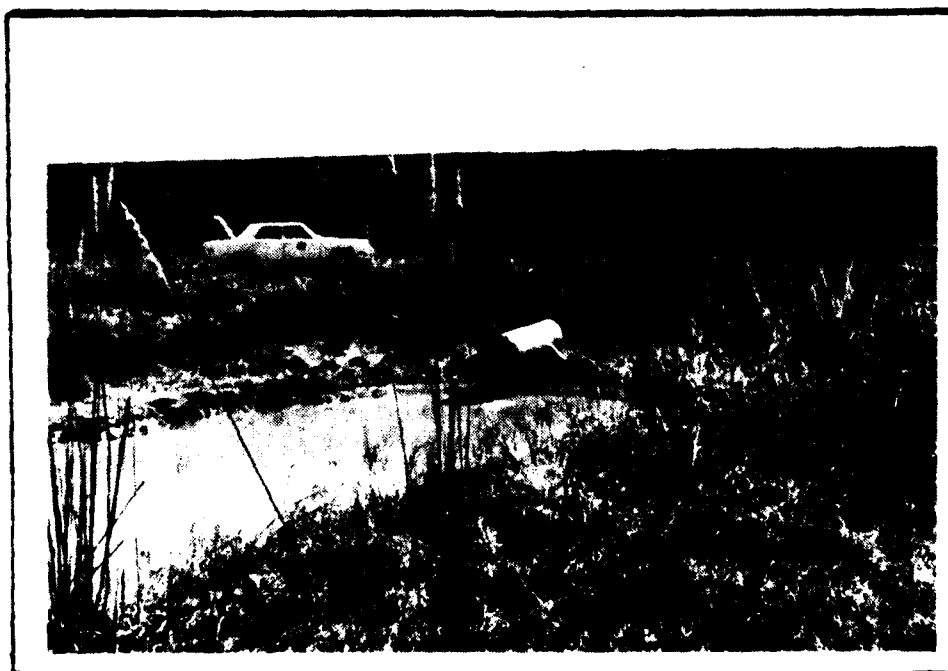
PHOTO NO .12

The pipe outlet gives the appearance that the culvert may also be in good condition. It is free of noteworthy weathering and gives no indication that seepage may have occurred around its periphery (see photo no. 12).

- Photo No. 12 - Principal spillway outlet.
- Photo No. 13 - Emergency spillway entrance channel looking upstream from control section.
- Photo No. 14 - Emergency spillway exit channel looking downstream from control section.

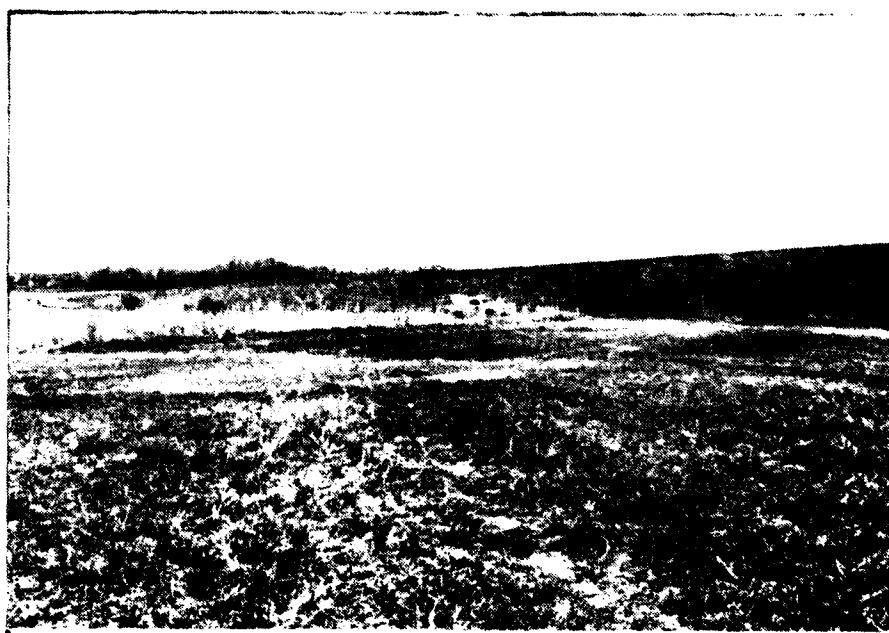
PHOTO NO. 15

- Photo No. 15 - View of dam, right of principal spillway, from downstream.
- Photo No. 16 - Trailer park and U. S. Highway 51 in background.
- Photo No. 17 - Trailer park ninety degrees right of Photo No. 16. Hyde Creek runs under bridge where car is crossing.

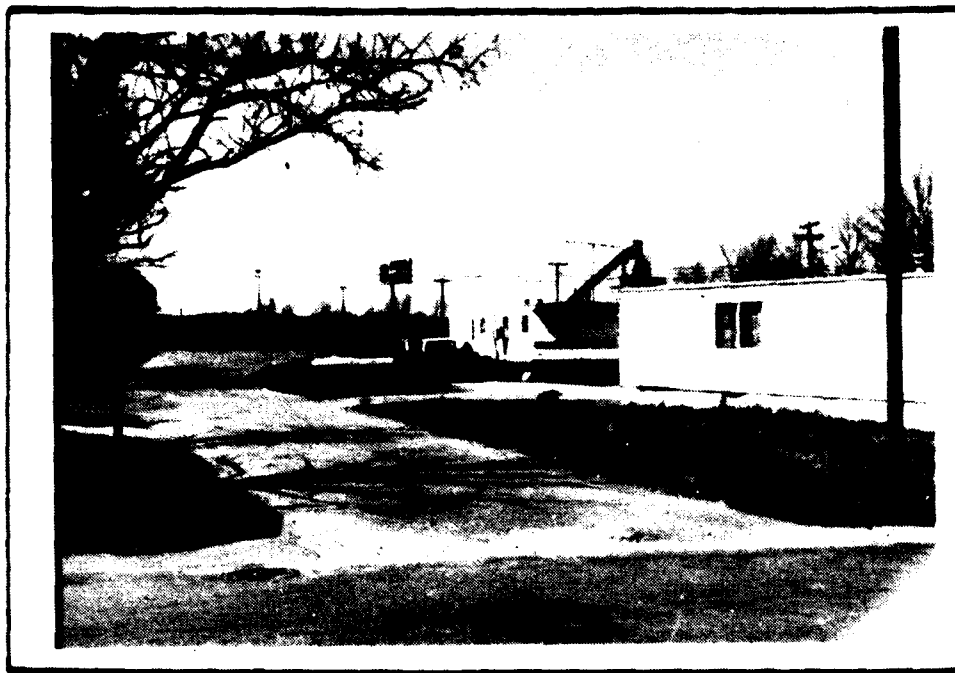
PHOTO NO .16

- 2.3 Size and Hazard Classification - Based on a maximum storage capacity of 2,400 acre-feet (including sediment pool) the dam is assigned a size classification of "intermediate". A federal hazard potential classification of "high" was chosen for the site because a sudden failure of the structure could possibly result in the loss of life of dozens of individuals living 2,700 feet downstream of the dam in a trailer park. An Illinois Central Rail line and a U. S. Highway 1,700 feet and 2,800 feet downstream respectively would also be affected (see photo nos. 16 & 17).
